# Design Guidance for Wetland-Road Crossings to Reduce Blanding's Turtle Mortality Risk

10 November 2023

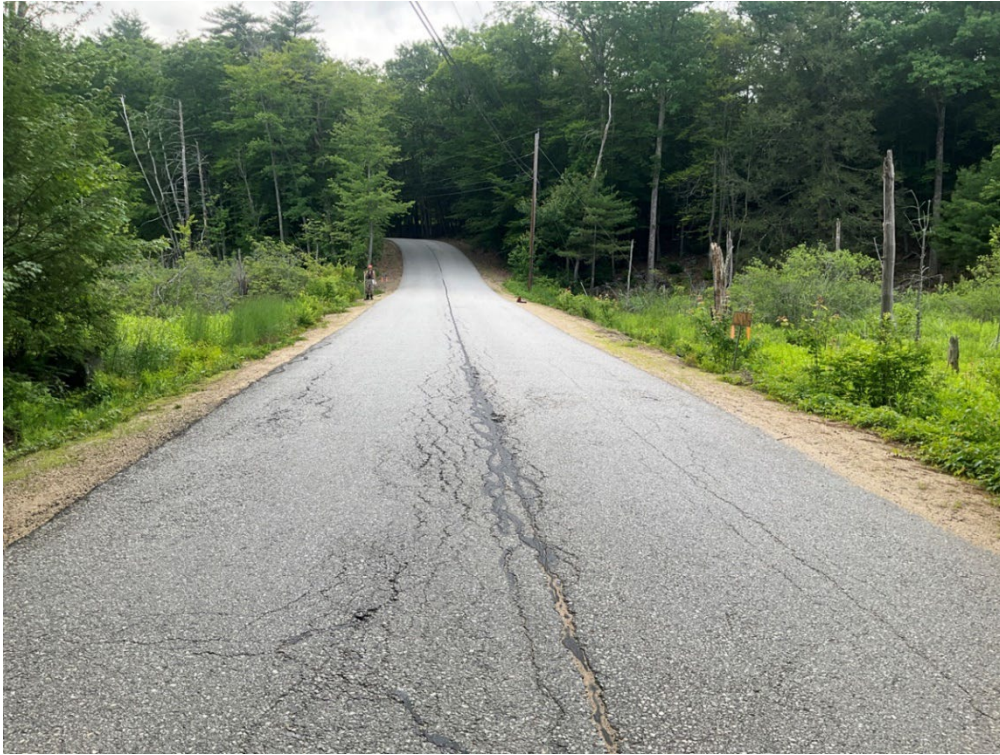
Figure 2. A likely turtle crossing hot spot is where a road bisects a wetland or aquatic system.

- (1) **Habitat:** Blanding's turtle habitat includes wetland habitats with permanent shallow water and emergent vegetation such as marshes, swamps, bogs, and ponds. Blanding's turtles use vernal pools extensively in spring and while traveling through the landscape. They may use slow rivers and streams as mechanisms for dispersal between wetlands and use terrestrial habitats for nesting and travel among wetlands. While Blanding's turtle movements are dispersed and extensive, a likely hotspot for road crossings is where a road bisects a wetland (Figure 2).

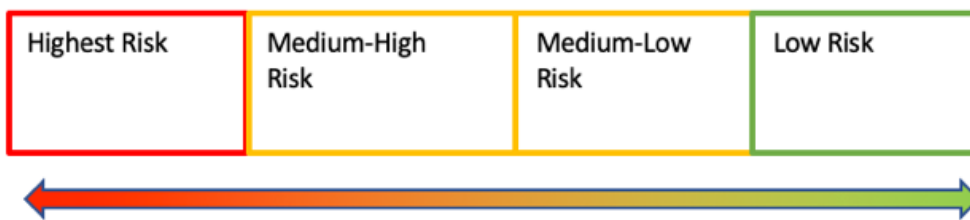
Figure 3. Stream-Road Crossing Classification for Risk of Turtle Mortality

The goal of the rubric is to organize a select group of road crossing structures into the four categories found in Figure 3: a spectrum of road mortality risk for Blanding's turtle.

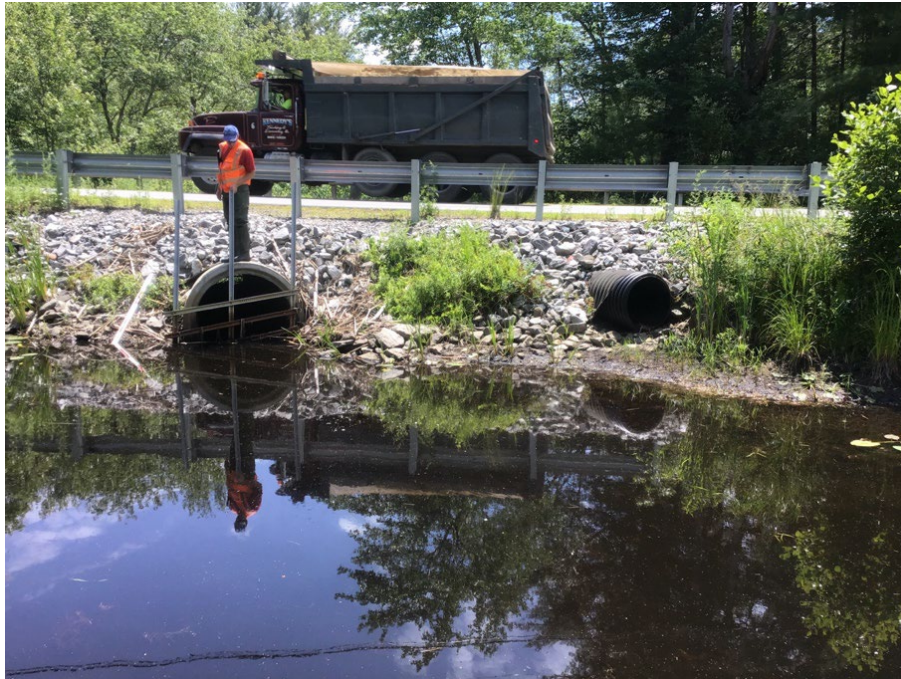
Figure 5. Relatively steep embankment slope by the culvert inlets with rip rap on the embankment, reducing riparian continuity. In this instance, passage from the water to the road is relatively difficult compared to Figure 6 and would likely take more energy, or potentially be a barrier.

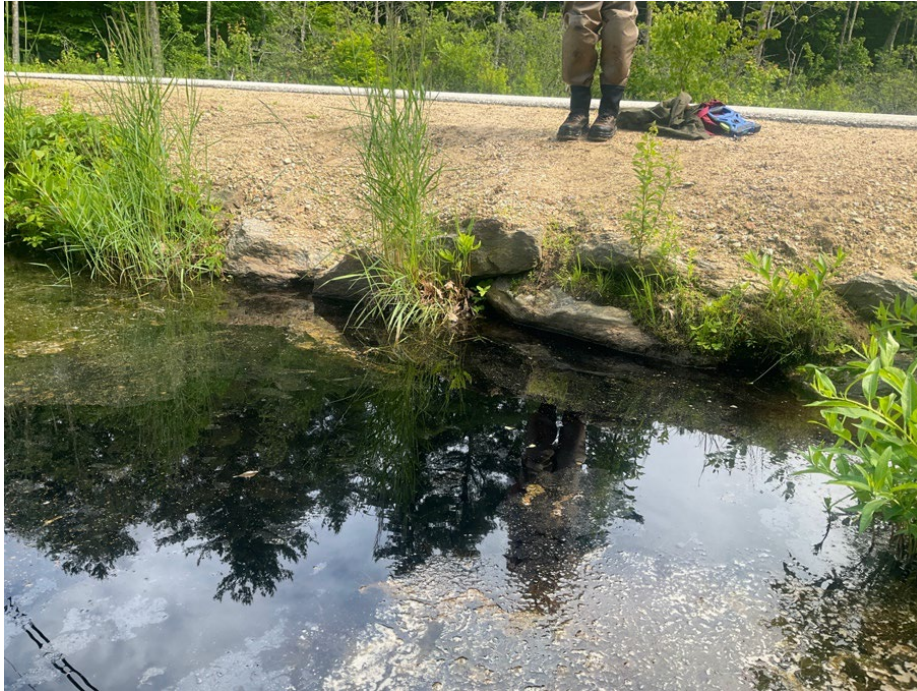
Figure 6. An embankment with a low slope and riparian continuity, making the travel from the water surface to the road easy and accessible.

allow easy passage for a turtle from the wetland to the road (Figure 6). Such a setting provides very little barrier and results in greater vulnerability for turtles at the crossing.

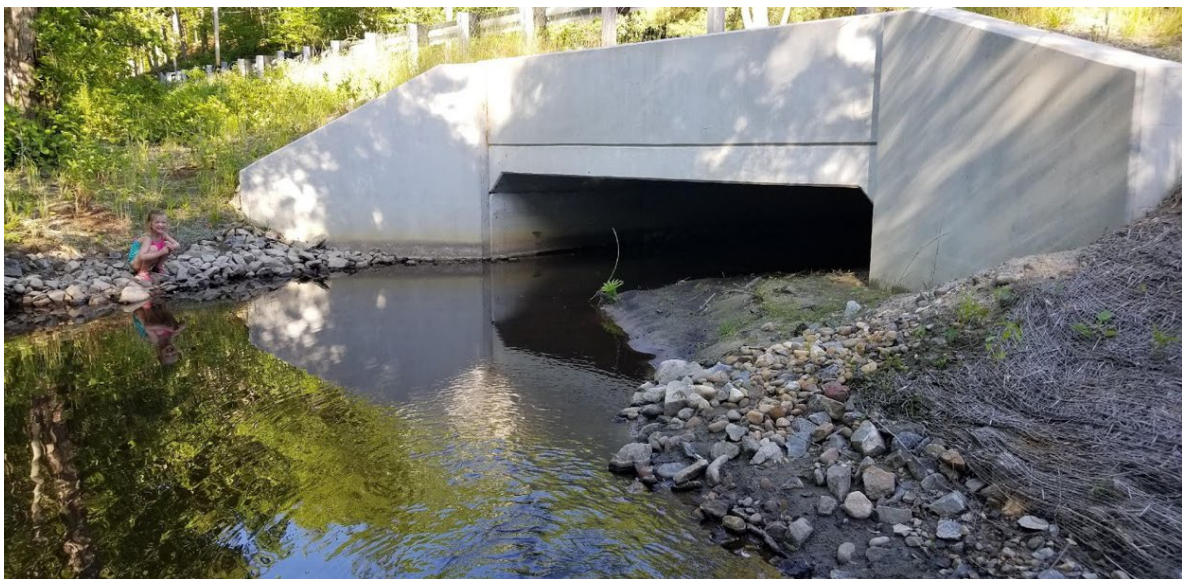
Figure 7. Lack of riparian continuity leading into and through a structure due to cobble and rip rap placed on banks.

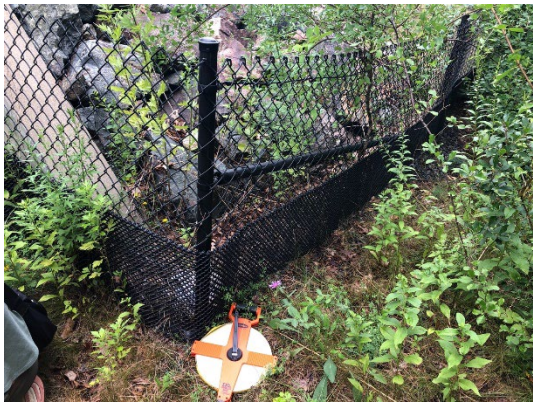
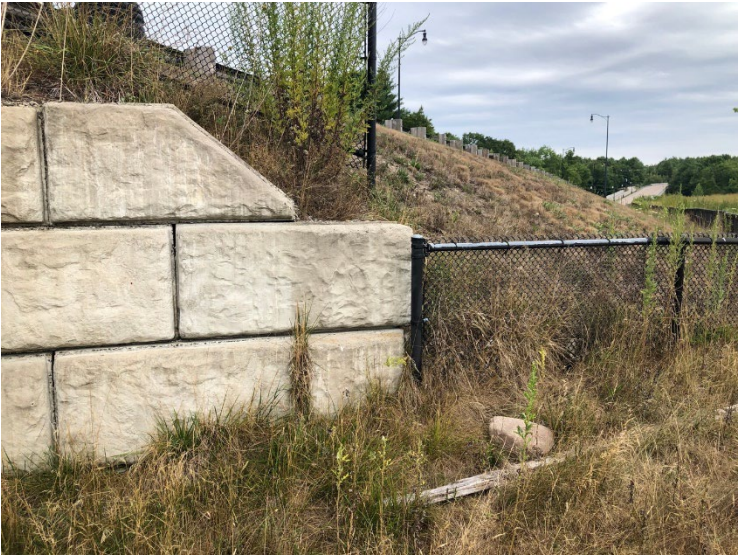
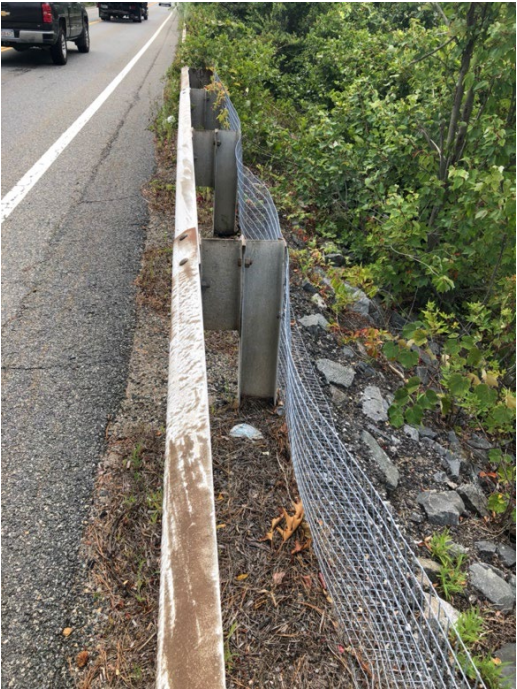
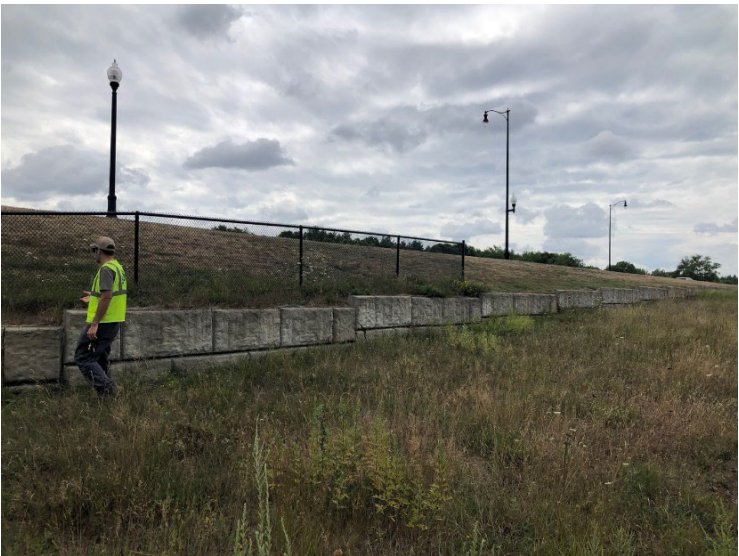
Figure 8a. Various turtle barrier strategies.

To prevent turtles from accessing a road, and therefore reduce the number of turtles killed on a roadway, a barrier feature such as a wall or fence is recommended. The barrier/fence serves two purposes: to prevent turtles from accessing the road and to guide turtles into a crossing structure under the road. Appropriately located, designed, and maintained barriers have been shown to significantly reduce turtle road mortality (Aresco 2005, Langen 2011, Crawford et al. 2017, Markle et al. 2017, Boyle et al. 2021, Read & Thompson 2021). Ideally, the wall or fence also guides turtles to a passage structure or underpass, such as a culvert or bridge, thus maintaining functional habitat connectivity. Barrier features are a simple and effective way to upgrade a crossing structure for turtle passage. Figures 8a and 8b display various turtle barrier examples.

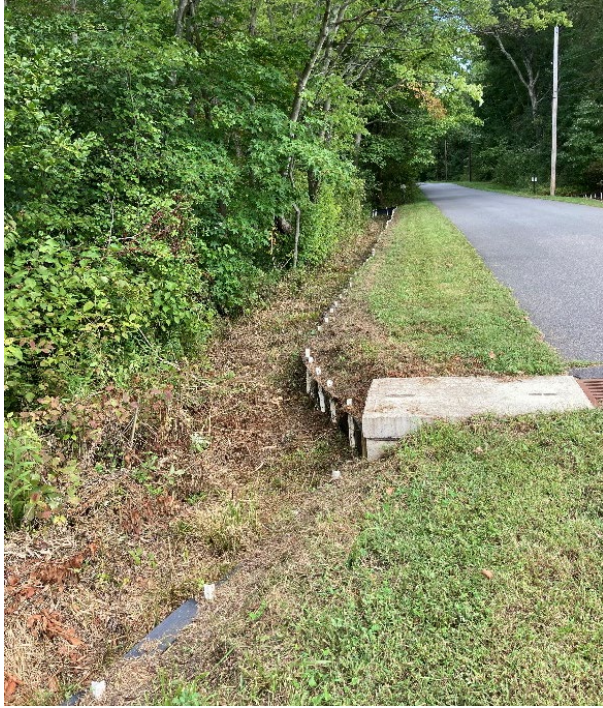
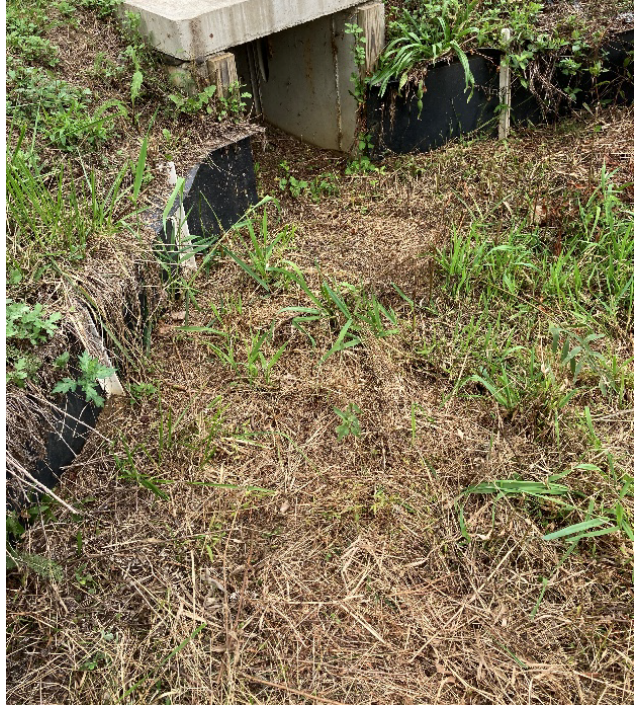
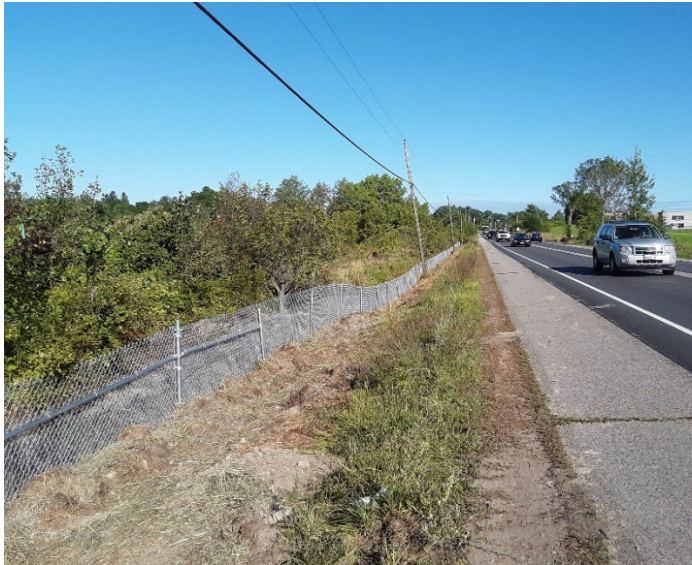
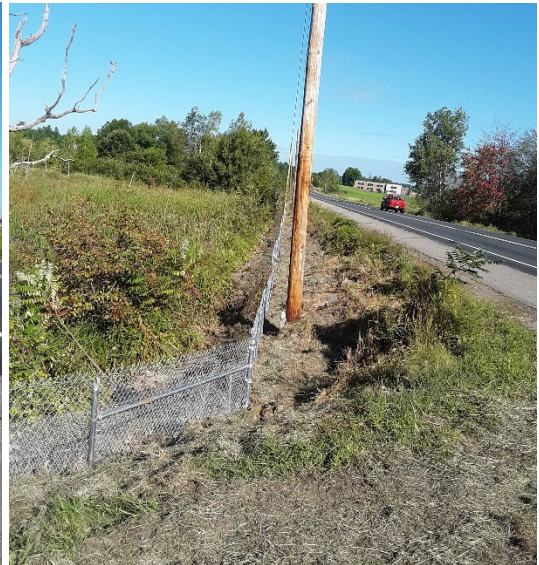
Figure 8b. Various turtle barrier strategies.

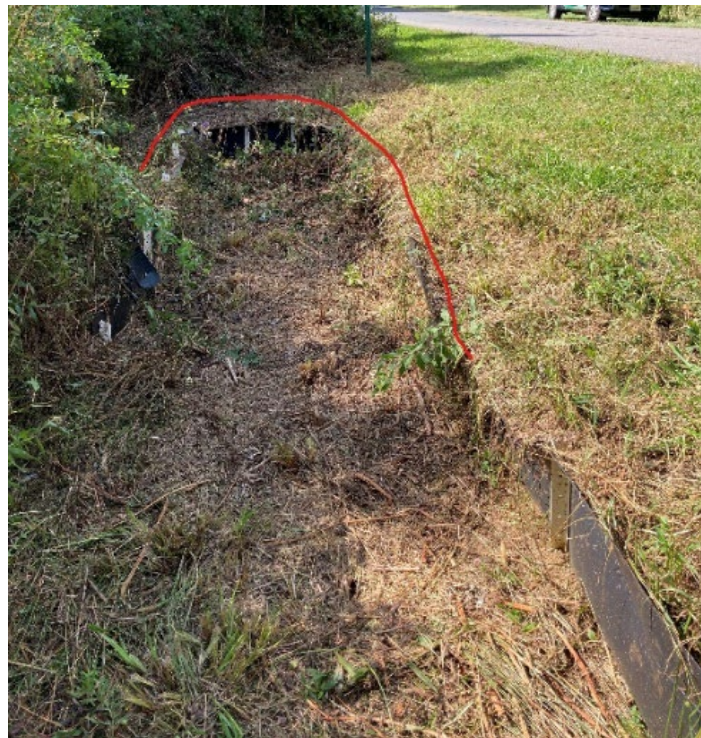
Figure 11. Curved turtle fence end to deter turtle from going around the fence. This barrier is built into the slope so it is at grade on the roadside so that an animal that is on the road is not trapped and may drop over the lip to the wetland but not move from wetland to the road.

Include features to prevent turtles from getting trapped on the road. For example, a barrier built into the slope at grade on the road side so that an animal may drop over the lip from the road (Figures 9 and 11). Additional advantages of a barrier wall built into the slope are aesthetics (not visually conspicuous from roadway), easy vegetative maintenance, uninterrupted water flows, and increased durability.

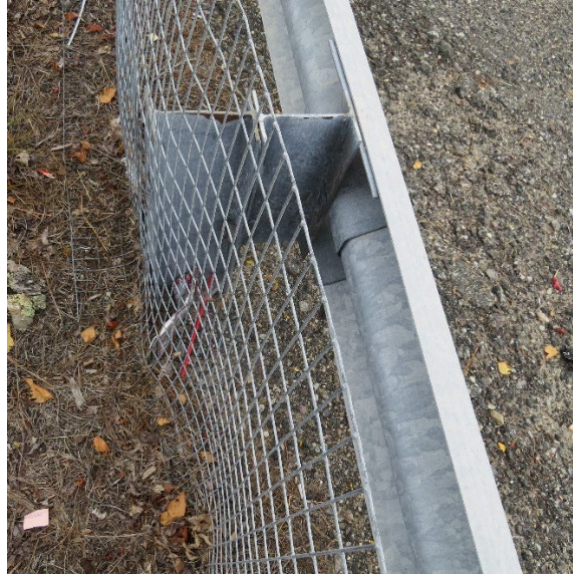
Figure 12. Turtle fence installed behind an existing guardrail.

- The barrier may be combined with other road barriers such as a guard rail (Figure 12). It should be noted that attaching a fence to a guard rail as depicted may not meet local or state design codes.

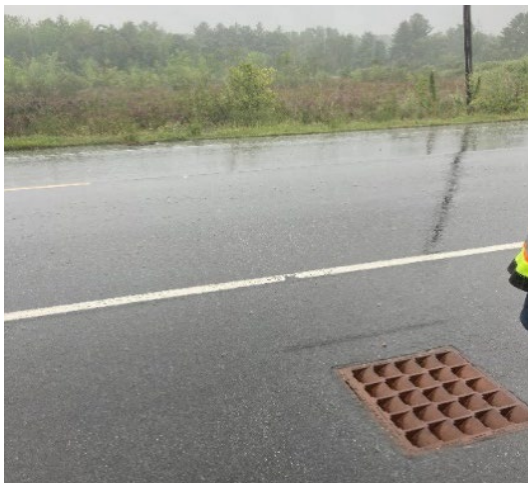
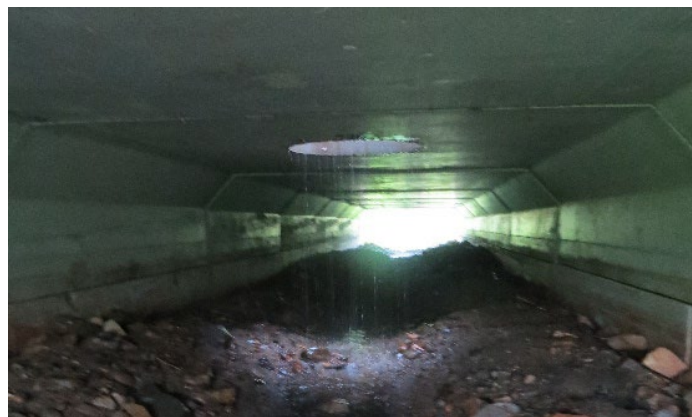
Figure 13. A grate in the shoulder of a roadway provides light to a culvert; installing the grate in the shoulder of the road allows it to be below road grade improving snowplow safety.

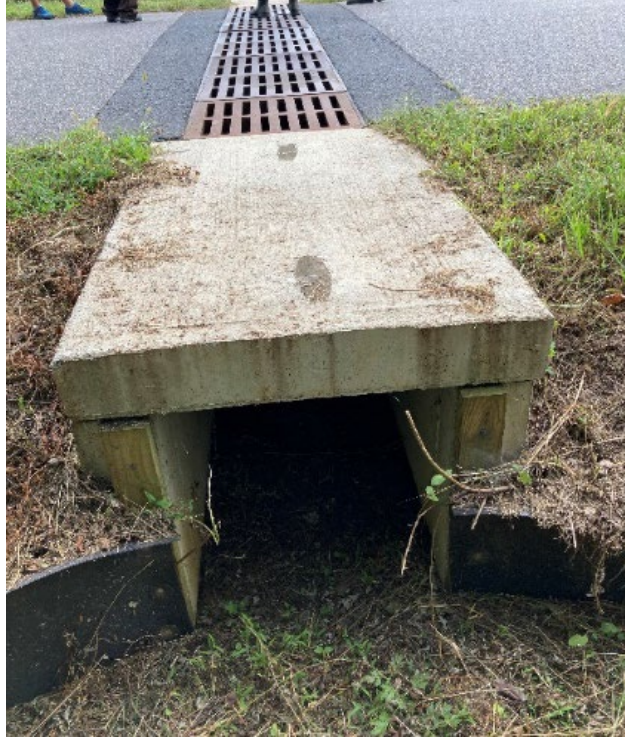
Figure 14. A dry culvert with a grated cover.

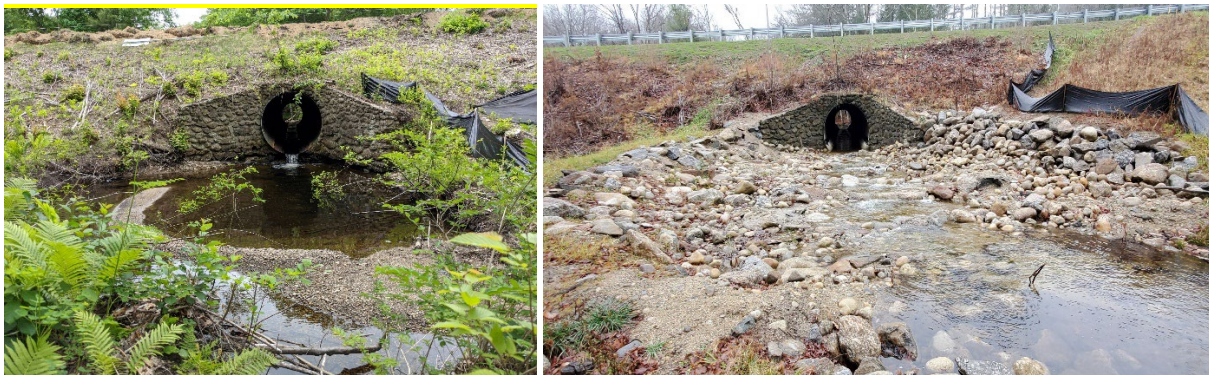
Figure 15. Perched culvert (left) and same culvert with a rock ramp (right).

Perched culverts may prevent safe passage for turtles that cannot jump or climb into the perched culvert. This then forces turtles to travel overland and increases their risk of road mortality. New culverts should be set at grade or embedded at grade. For existing culverts that are perched, if replacement is not being considered, create a more gradual slope (ramp) between the culvert and the surface of the wetland using natural substrate. Existing culverts that are perched may be modified by constructing a ramp just downstream to completely eliminate the perched condition (Figure 15).

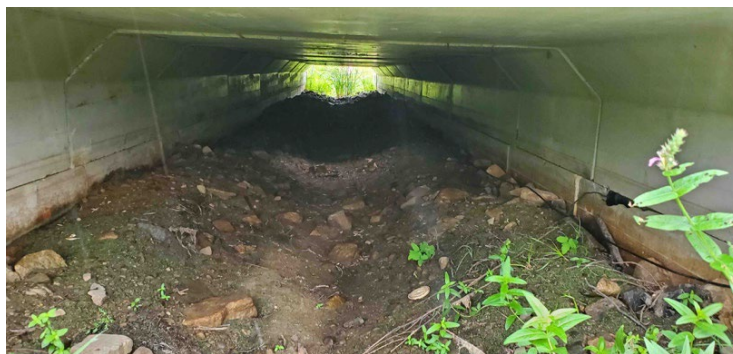
Figure 16. Dedicated turtle crossing structure.

Turtles in general are not strong swimmers. Some species such as Blanding's may avoid submerged culverts and prefer to move on land. Therefore submerged culverts or culverts with high velocities are not optimal components of continuous habitat. If an existing culvert is submerged, that culvert could be replaced, with one set higher, or a separate turtle crossing installed nearby. No strict guidance is available on the maximum culvert water velocity for turtle passage: however, the stream characteristics away from the effects of the culvert are the best guide. At the range of flows during the movement periods, culvert velocities should mimic those in the stream. The high water velocity problem may be avoided if there is a wildlife bench in the culvert, or, as with the water depth solution, a separate turtle crossing constructed (Figures 16 and 17).

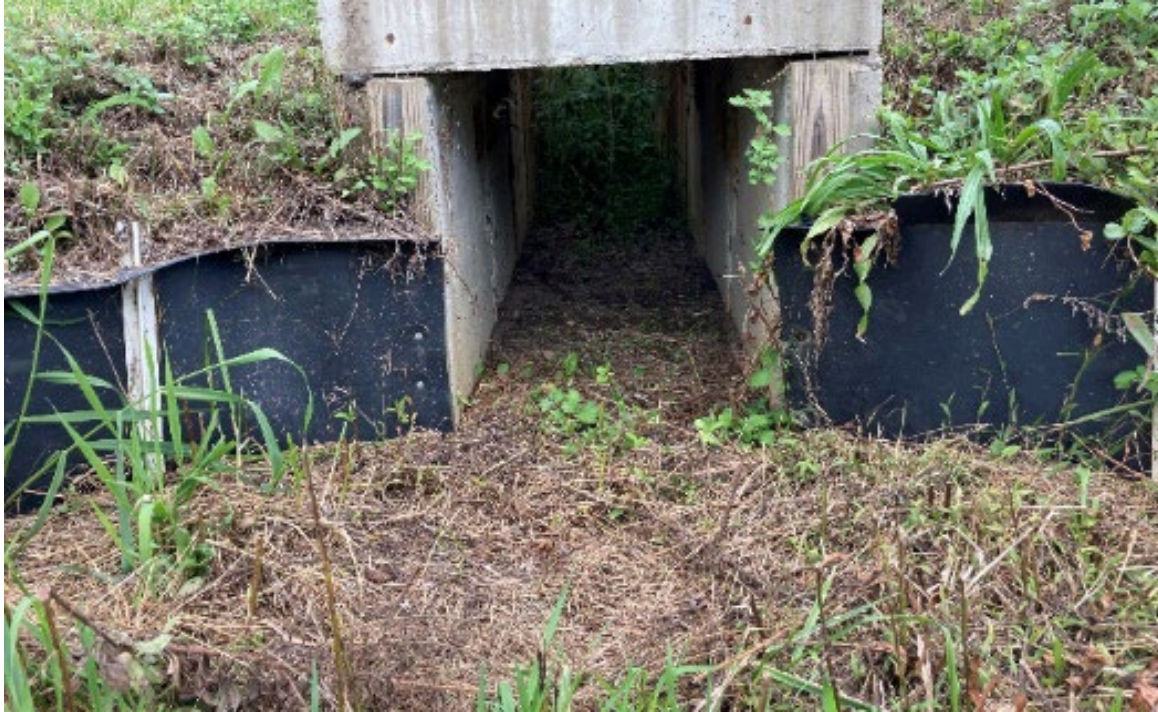
Figure 17. Example of a dry passage culvert.

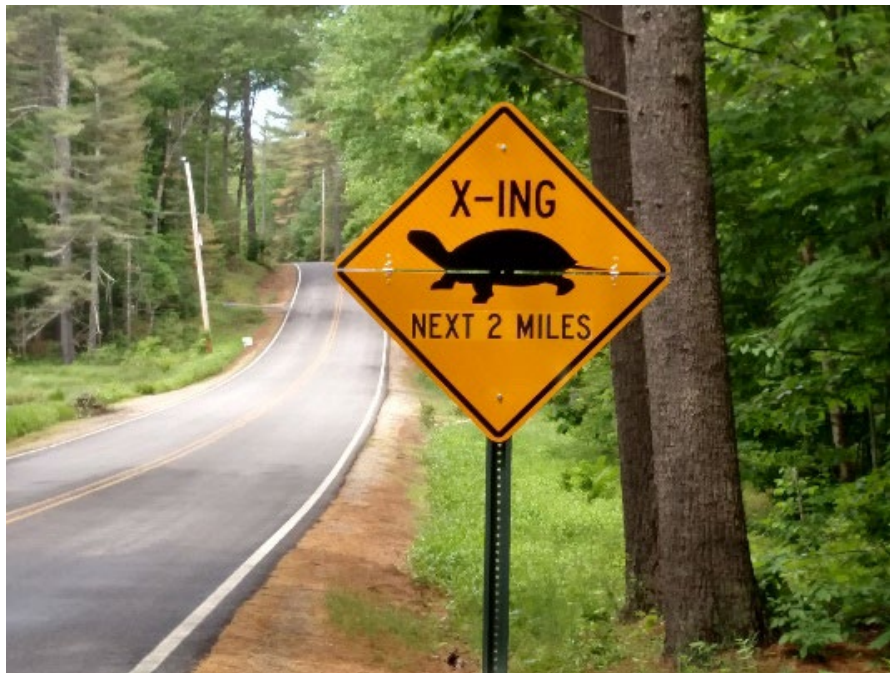
Figure 18. Hinged turtle crossing sign that can be opened during times of highest risk of turtles on crossing roads.

One method to reduce turtle mortalities on roads is to increase driver awareness (Figure 18). Road signs warning motorists that turtles may be crossing in the near distance may make drivers more aware. Signage is most effective when combined with other mitigation measures (for example barrier fencing, underpass structures, traffic calming/speed reduction, improved visibility, etc.) and it is best not to use signage exclusively, rather, it is recommended to

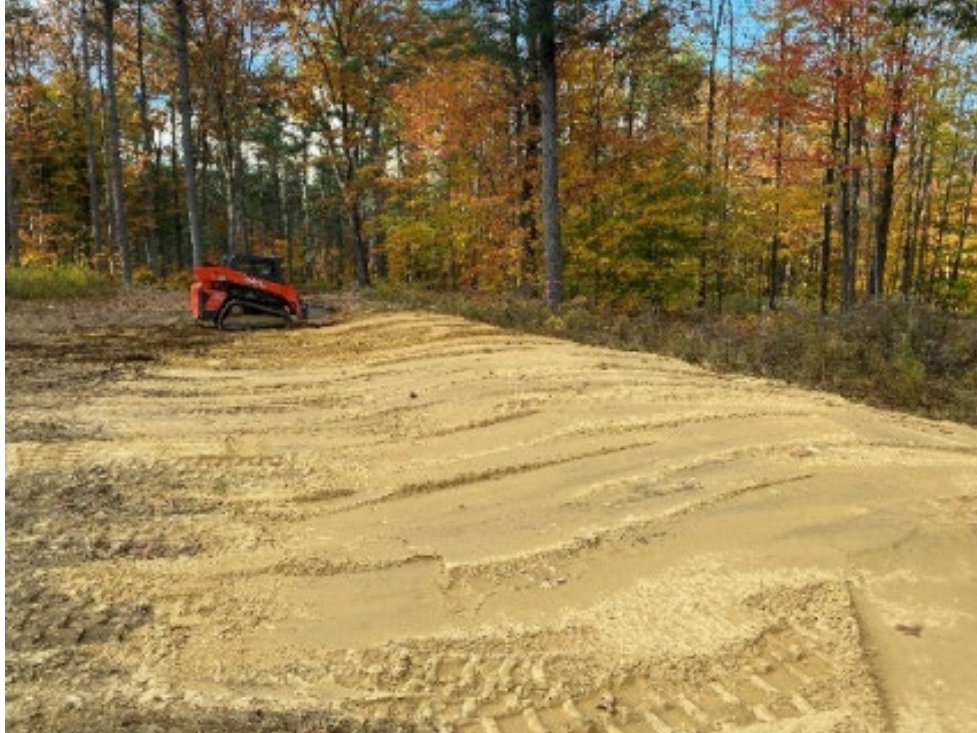
Figure 20. Creation of a turtle nesting site.

Turtles may encounter roads on their travels to nesting locations OR may be attracted to nesting sites along roadsides. The creation of safe nesting sites that allow travel from wetland habitats to nesting sites without crossing roads may reduce turtle mortality. It is recommended that you consult with a NHFG Biologist for technical assistance on the location and design of nest sites. In general, a turtle nest site habitat is open (unshaded), loose, bare soil or sand areas adjacent to or with 200 meters of wetlands (Figure 20).

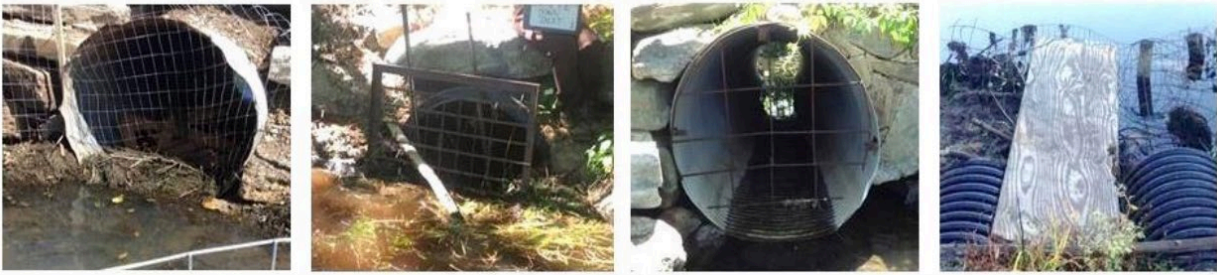
Screens at either the culvert inlet or outlet likely prevent turtles and other wildlife from accessing the culvert and prevent passage through the structure. Examples of typical screens are found in the photos below {photos taken from the New Hampshire Stream Crossing Initiative Field Manual (2019)}.

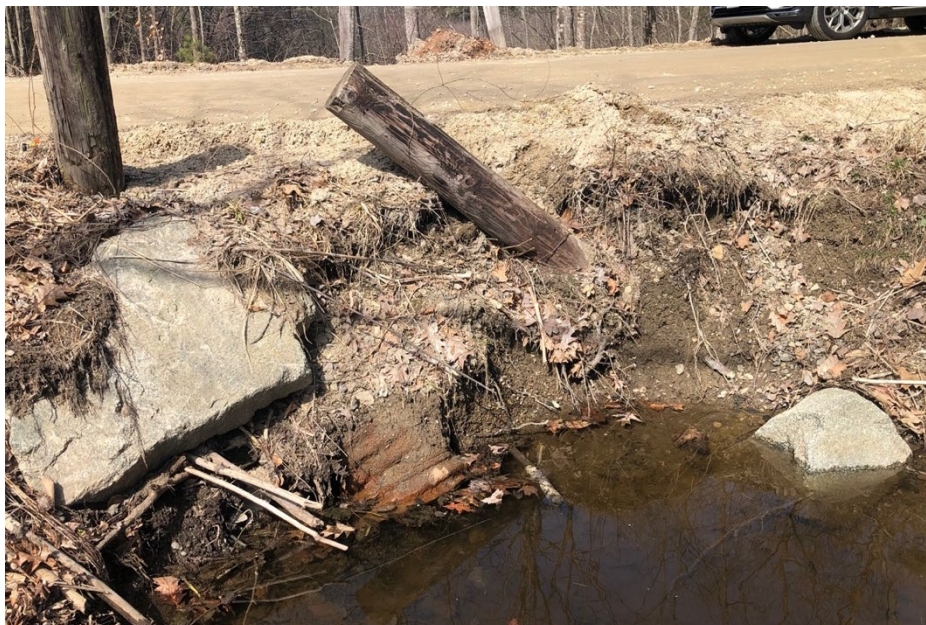
Record other abnormal visible blockages of the structure. Examples may include structural disrepair where either inlet or outlet is crushed, buried, or otherwise un-passable. The following photo shows an inlet (round corrugated pipe) that has been crushed and is blocked.

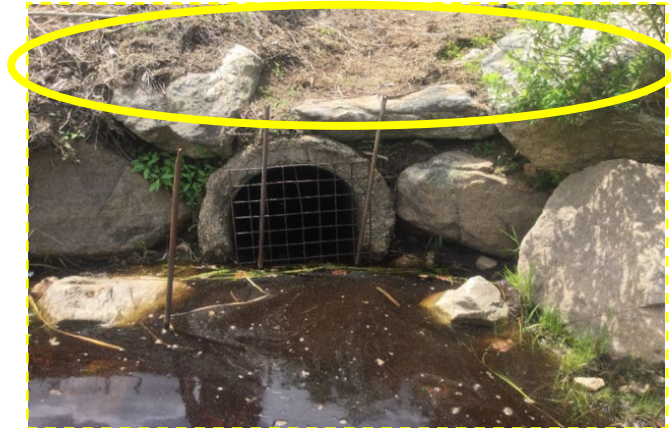
The embankment is the area between the road and the crossing structure. It is often steep and is where a headwall may be located (yellow oval on following figure).

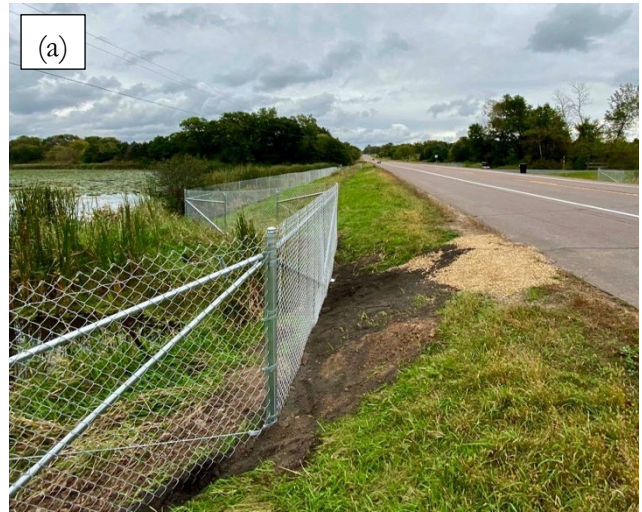
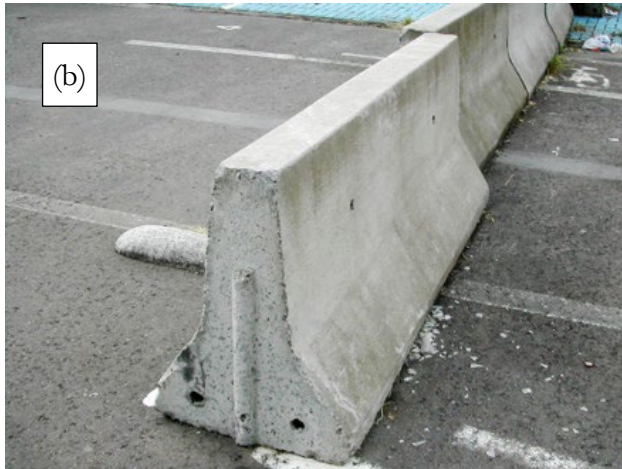
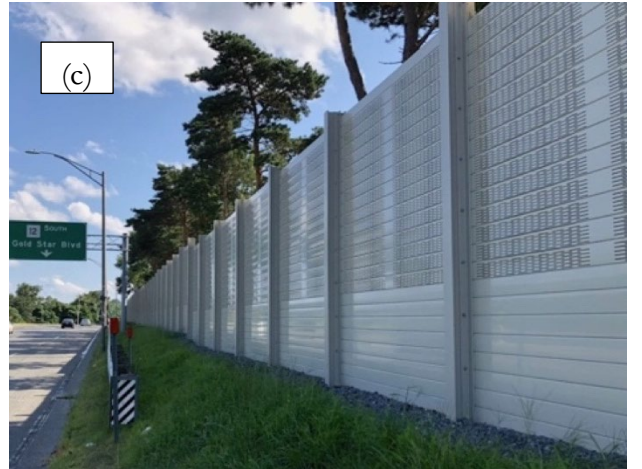
*Noise Barrier (c)*

Tall, solid barriers alongside major roads to reduce noise pollution away from road.

After identifying what type of barrier exists, examine the barrier to determine if it is turtle-proof. Literature has shown that fences obstruct turtles when they are embedded in the ground, are free of any holes or maintenance issues, curve back towards the wetland at the edges, and are at least two feet tall. Guard rails or other fencing that has large open areas are not considered turtle-proof fencing.

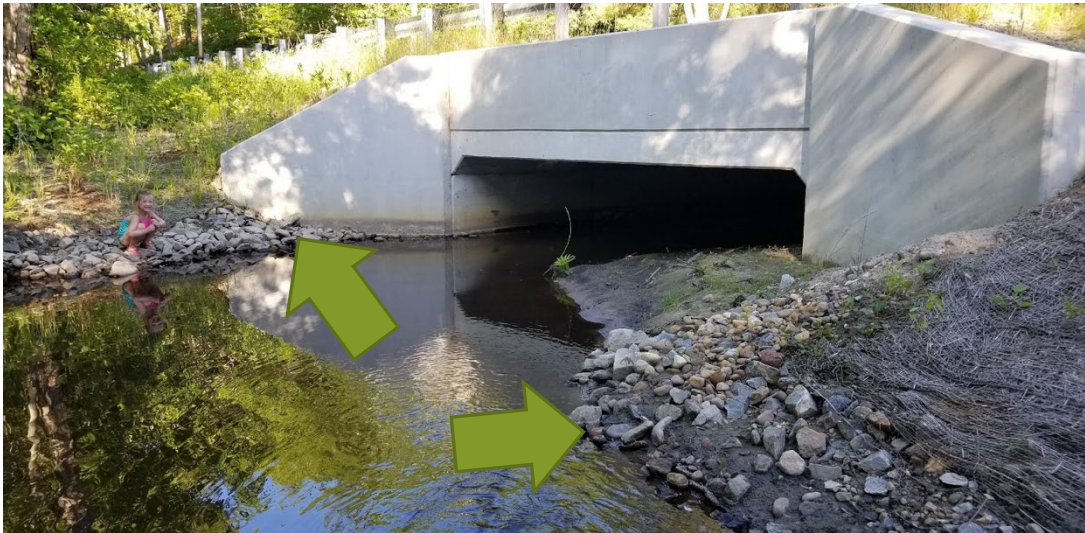
The example above shows a lack of riparian continuity: the cobble riprap on the left and right side of the banks disrupts the continuity of the sandy/silty substrate with young vegetation growing. The presence of a stonewall crossing the water body, banks, or embankment signals non-continuous riparian edge. Void-filled rip rap can improve turtle access here.

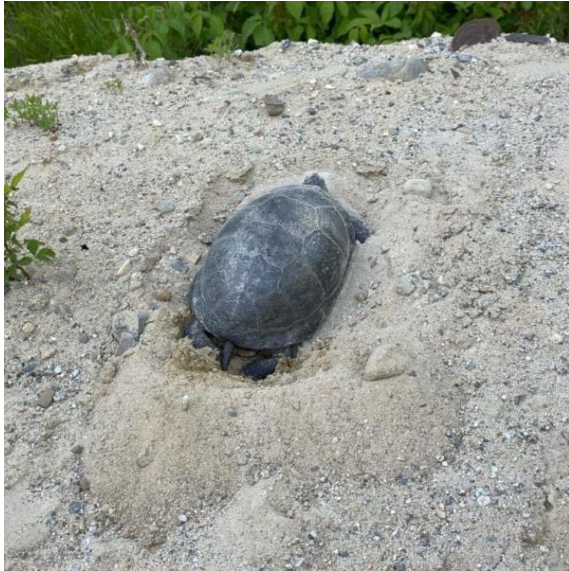
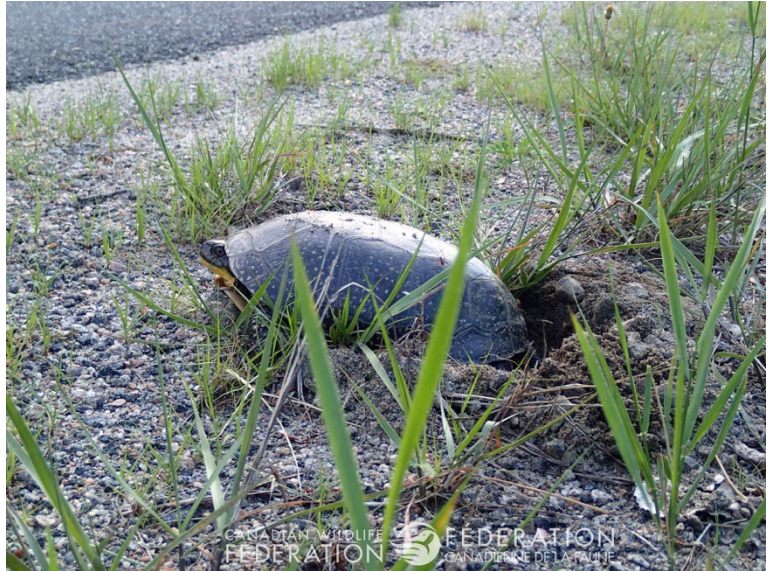
Blanding's turtles commonly nest in dry, sandy areas with no to low canopy cover (figure below). Nesting areas are often upland with grassy or little to no herbaceous vegetation. Disturbed areas such as the sides of roads (especially dirt roads) or farmlands are common turtle nesting sites. Blanding's turtles do not nest in or at the water's edge. Field surveyors

should indicate whether there are any potential turtle nesting sites near the crossing, take a photo, and identify where in relation to the structure and road the area is located.

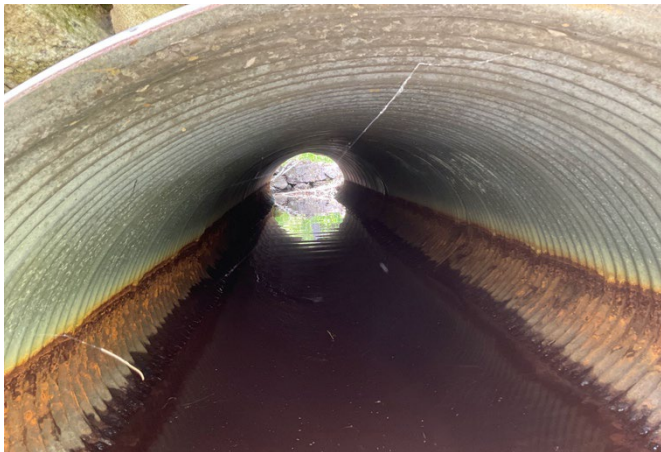
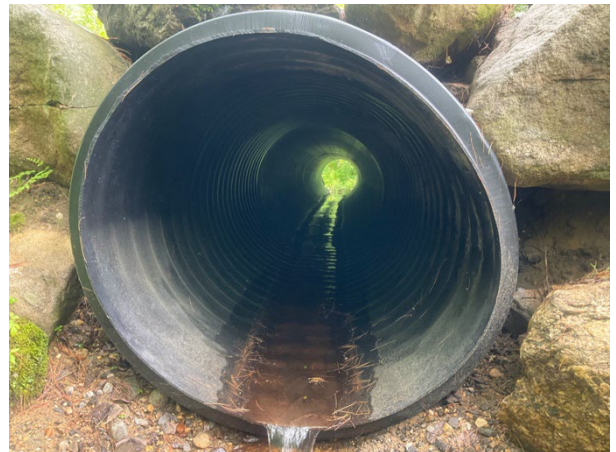
*Full:* The outlet is visible and enough light is able to enter the structure so that the culvert walls and water surface are visible (next figure).

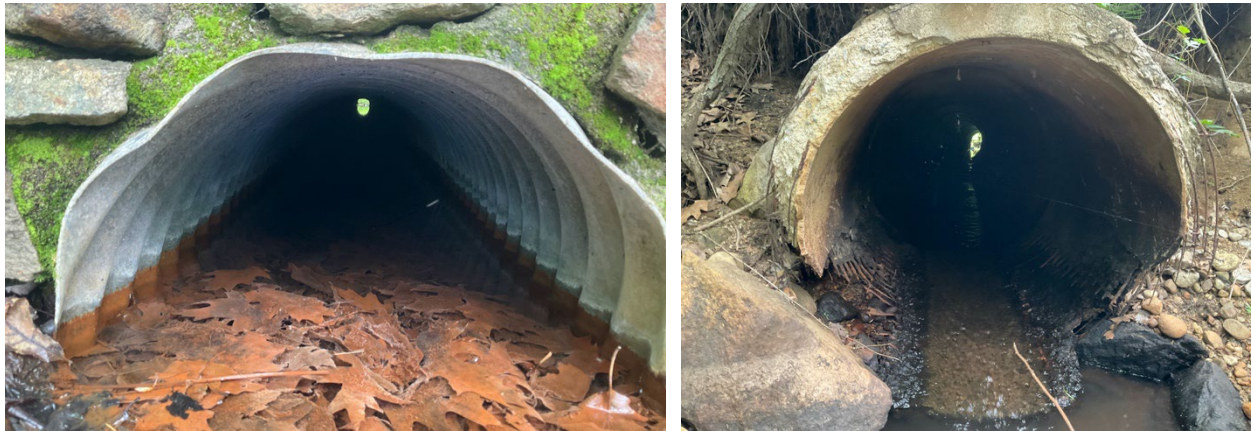
*Partial:* The outlet is visible, but inside the culvert may be dim or not entirely clear, the culvert sides and the water surface are not visible (next figure).

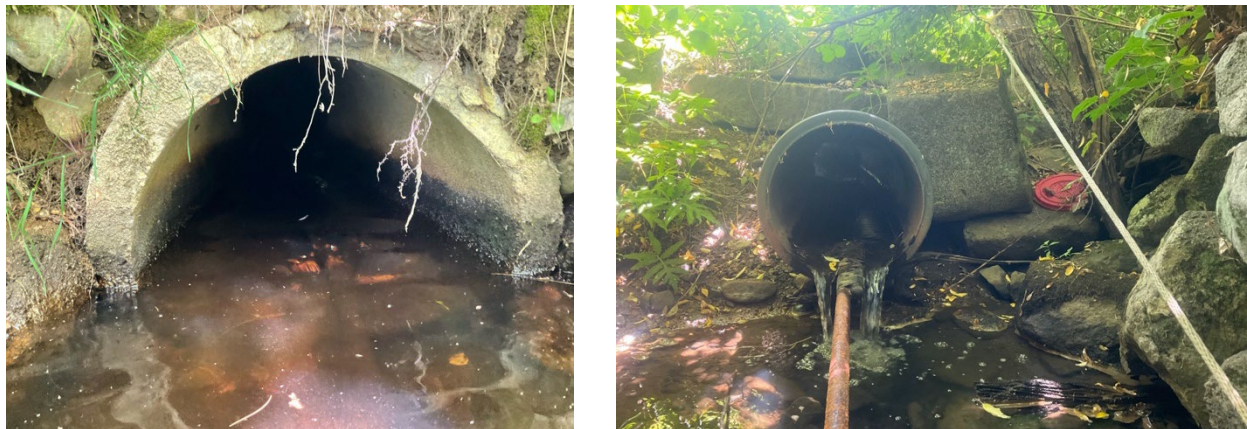
*None:* The outlet is not visible, and no light shows through the structure (next figure).

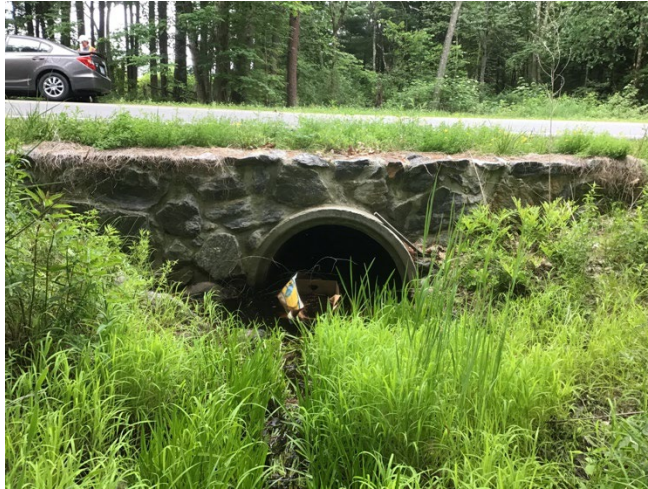
INLET

The existing culvert conditions may be viewed in the pictures below.

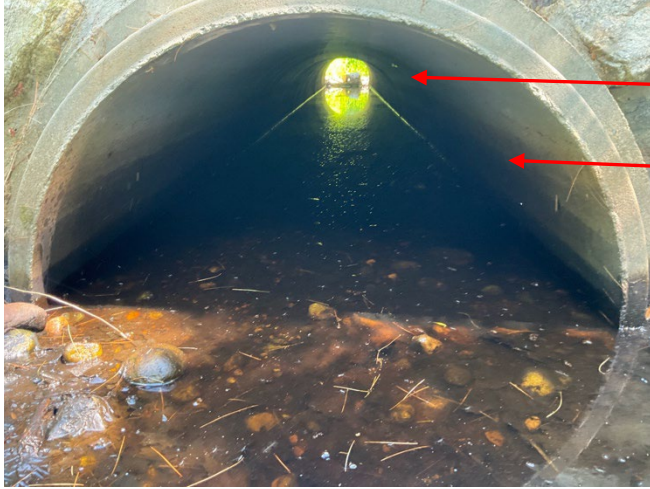
Outlet is completely visible from inlet

There is enough light in the structure to see the walls of the culvert and the surface of the water

**Outcome: FULL, looking through the culvert there is an abundance of light shining through the other side of the culvert such that the inside of the structure is visible.**

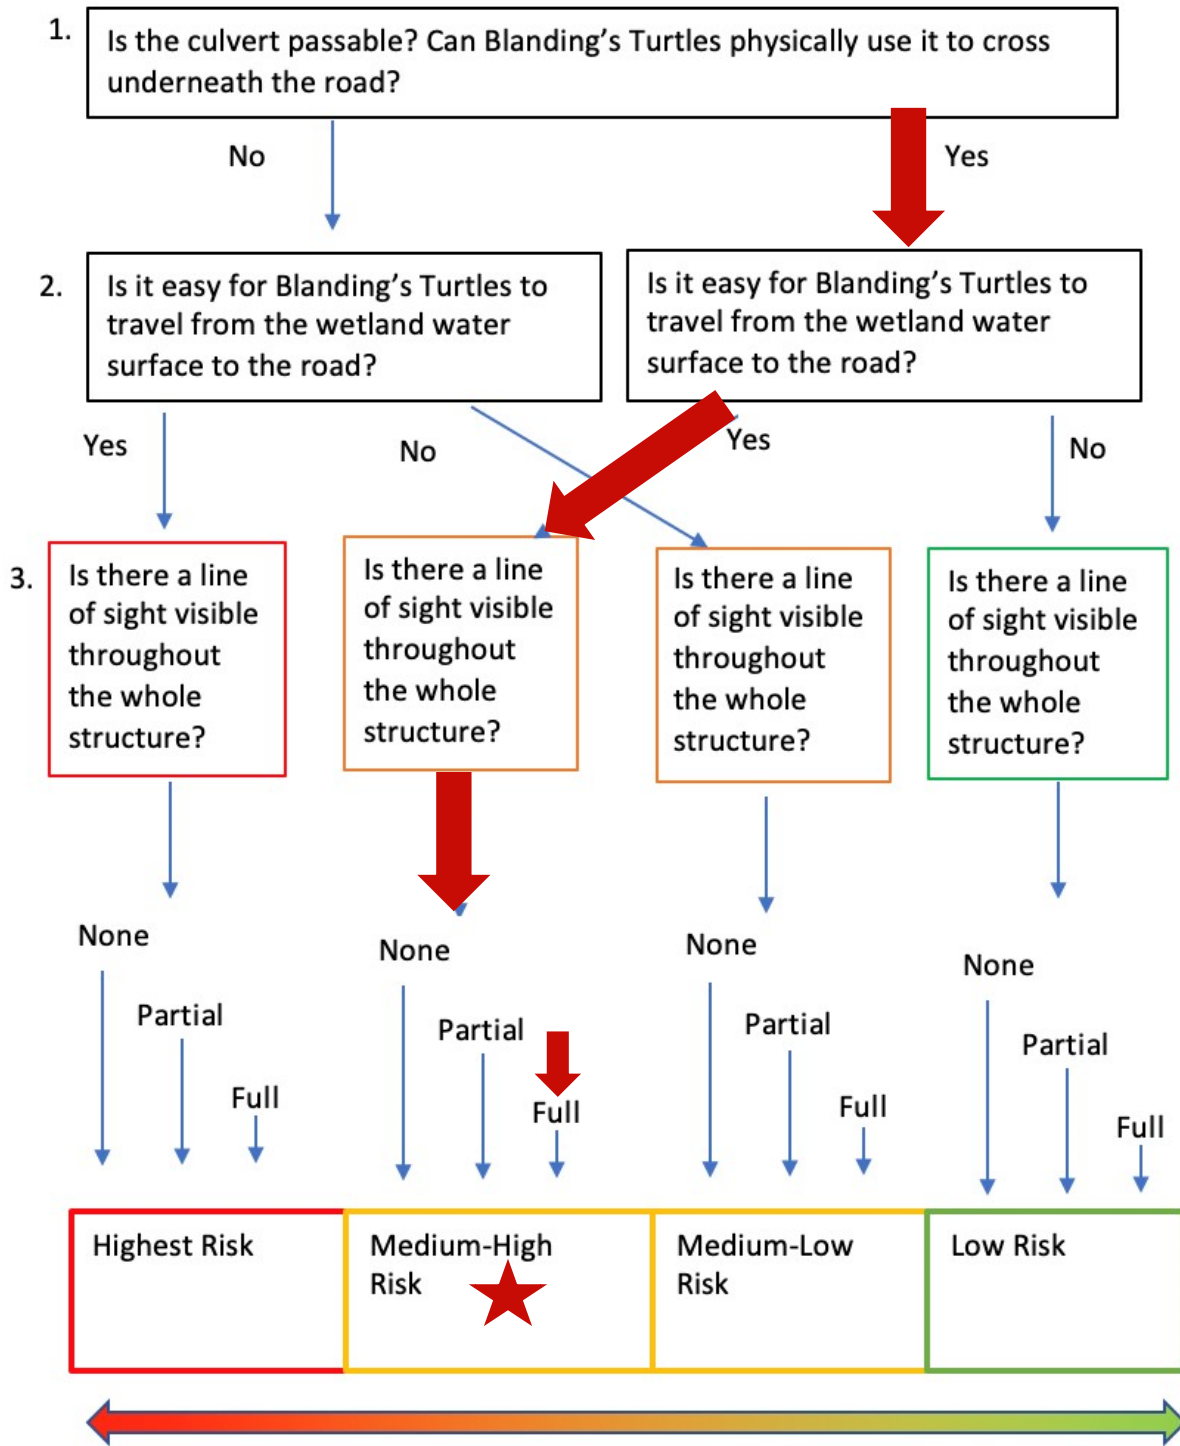
**Final outcome: Following the above flowchart, this culvert would fall into the “Medium-High Risk” category**
